Subject: 301 Mission Retrofit Supplemental Monitoring Report 072: Results as of September 19, 2022

Millennium Tower Perimeter Pile Upgrade: Instrumentation Monitoring Data  
City and County of San Francisco, California

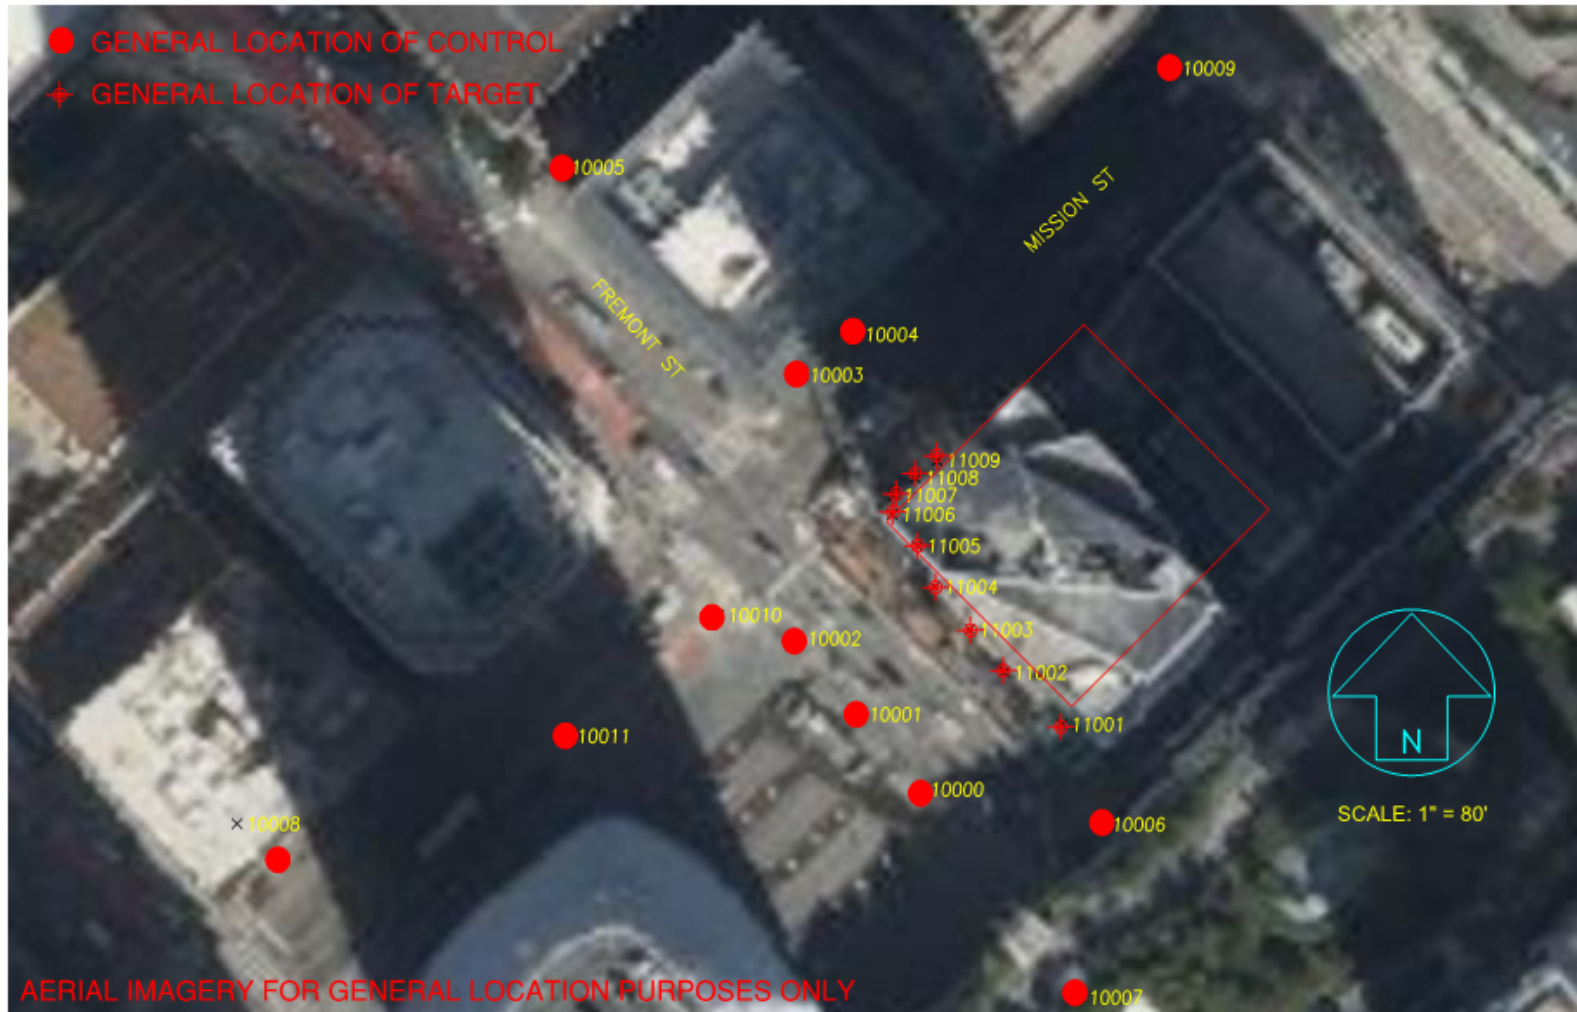
Project No: 19-009.00	Date: 5/3/2022	Created By: NBW	Checked By: DGM	Figure No: <b>072S-01</b>
-----------------------	----------------	-----------------	-----------------	---------------------------

Figure S-01 presents the locations of the survey prisms (including both control and target prisms) as referenced in later figures.

INSTRUMENT LOCATION MAP  
HORIZONTAL SURVEY CONTROL AND TARGET POINTS AT FIRST LEVEL

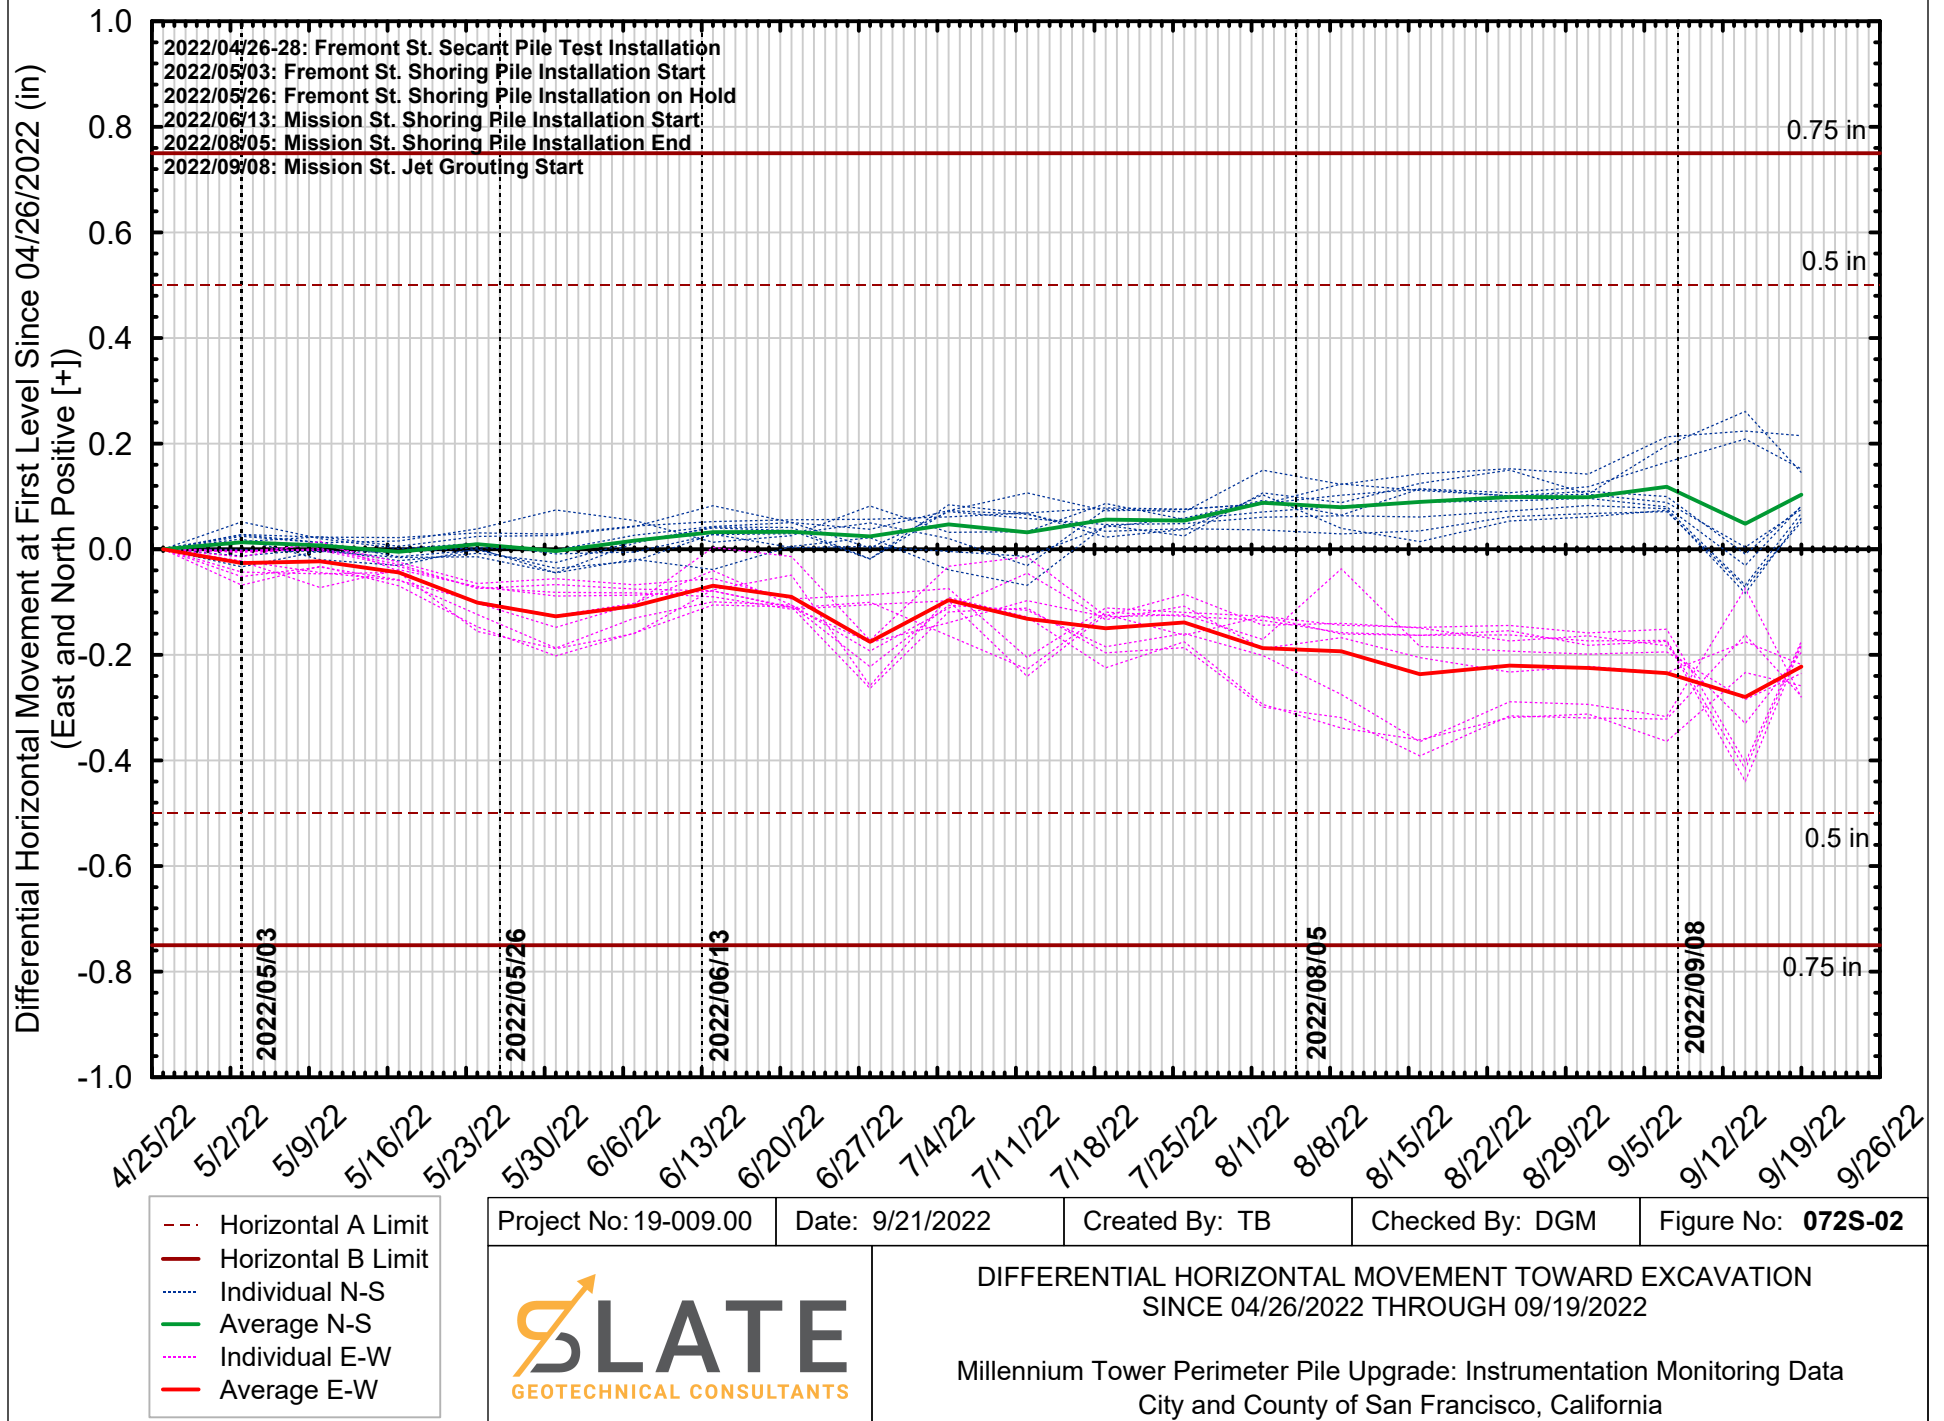
Figure S-02 – Differential Horizontal Movement Toward Excavation Since 04/26/2022 through 09/19/2022

Figure S-02 presents the differential horizontal movement toward the excavation at survey prisms installed at approximately one floor level above grade on the exterior of the building, as well as the average in each of the project north-south and east-west direction, since April 26, 2022, through September 19, 2022. Limits established in the aforementioned letter are included for reference.

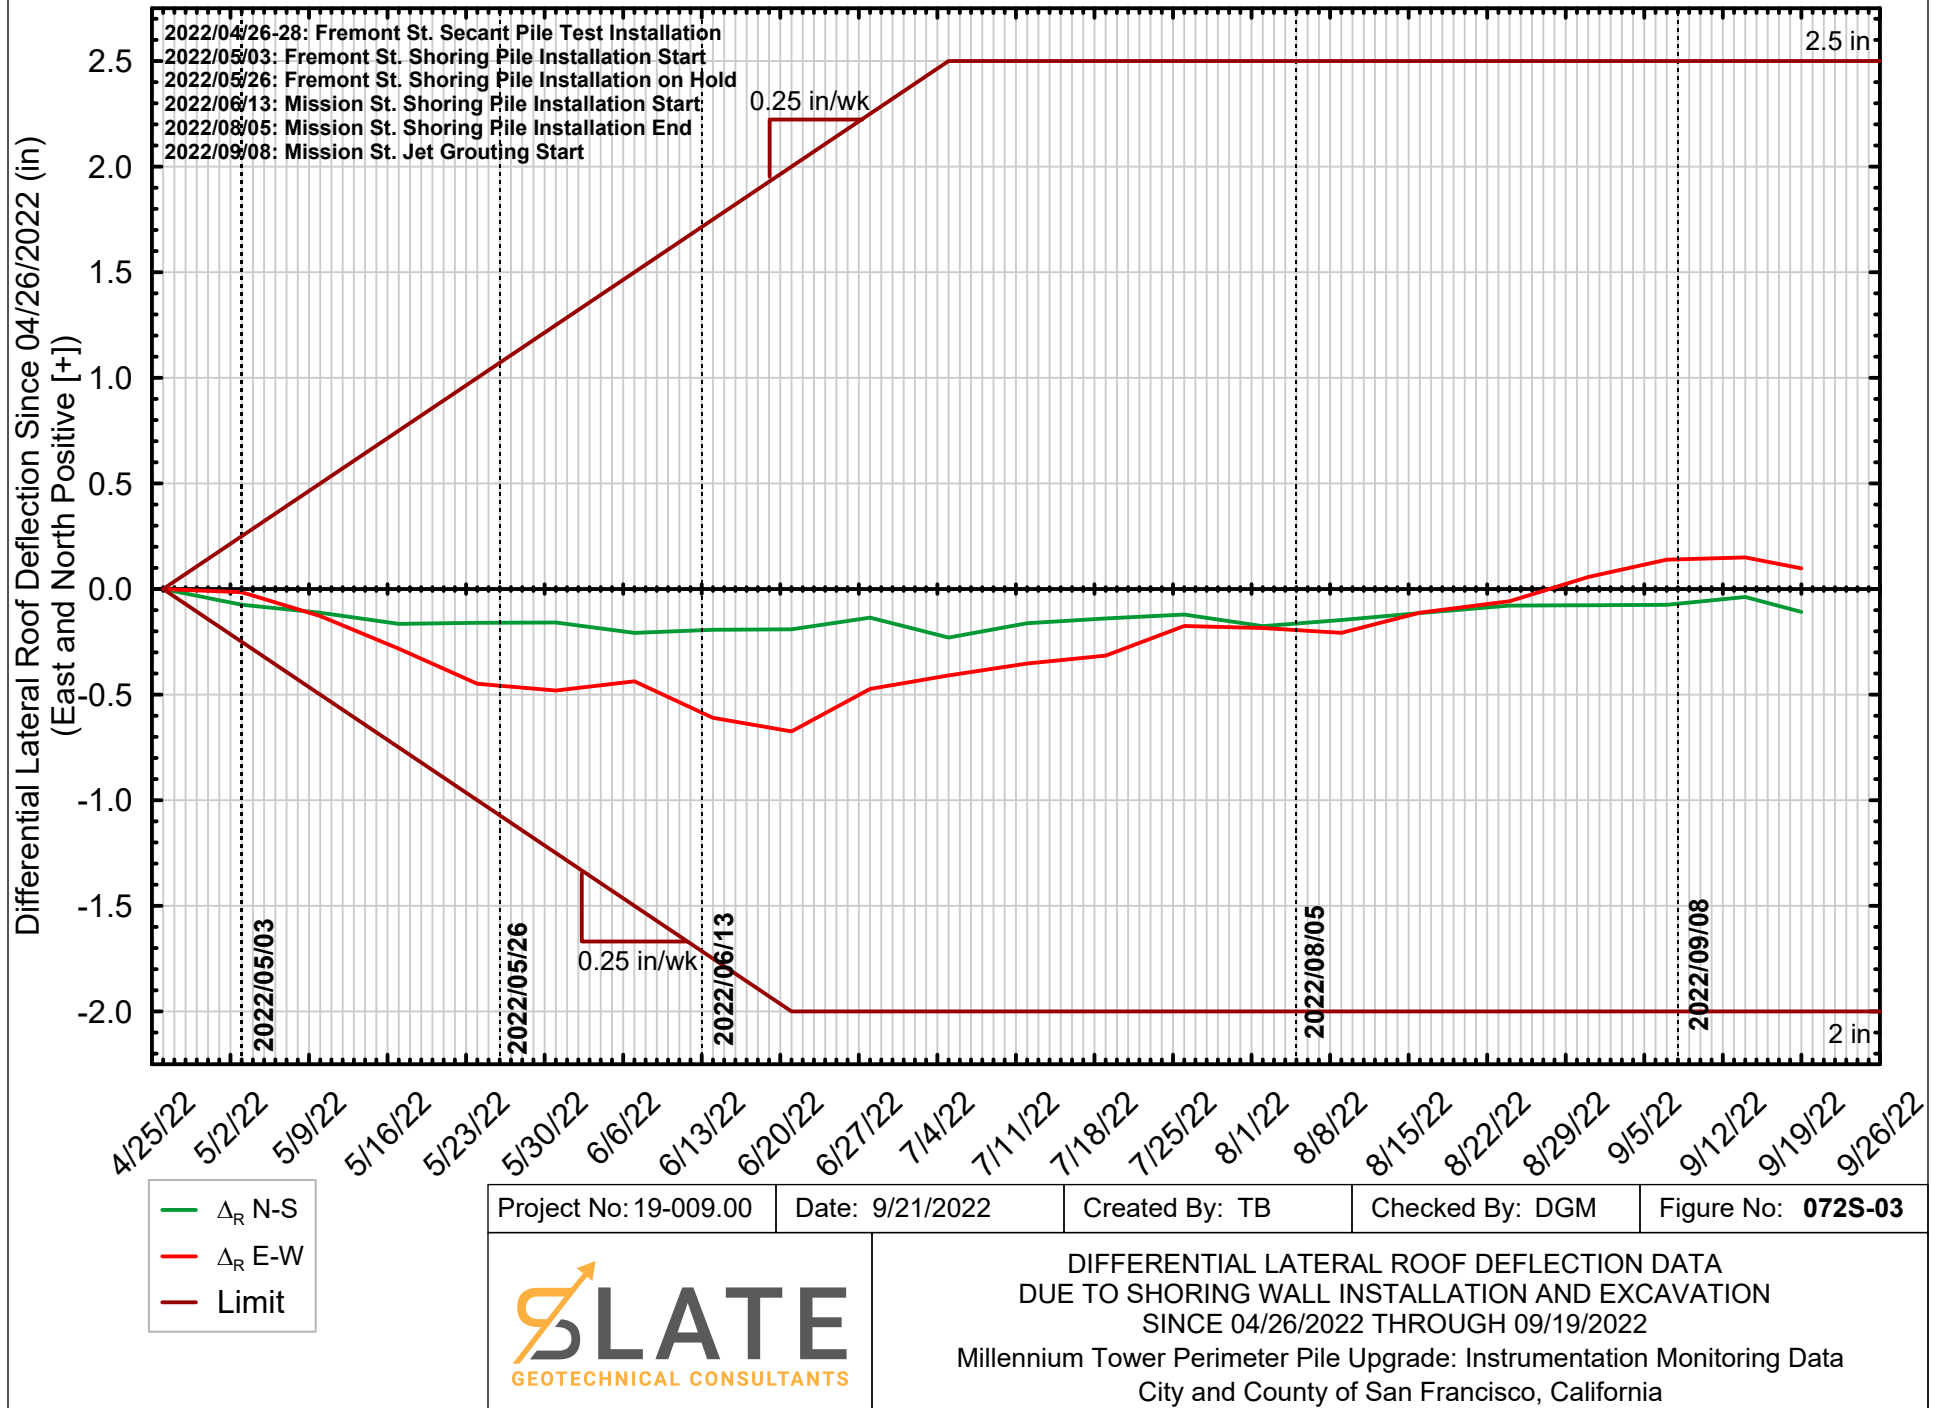
Figure S-03 – Differential Lateral Roof Deflection Data due to Shoring Wall Installation and Excavation since 04/26/2022 through 09/19/2022

Figure S-03 presents differential lateral roof deflection data due to shoring wall installation and excavation since April 26, 2022, through September 19, 2022. Limits established in the aforementioned letter are included for reference. Note that differential lateral roof deflection due to shoring wall installation and excavation is calculated following the aforementioned letter as:

$$\Delta_R = \Delta_{R-prism} - \Delta_H - \alpha T$$

where:  $\Delta_R$  is the computed differential lateral roof deflection due to shoring wall installation and excavation;  
 $\Delta_{R-prism}$  is the differential lateral roof deflection obtained from prism data;  
 $\Delta_H$  is the average differential horizontal movement "at-grade";  
 $\alpha$  is the weekly lateral roof deflection rate (computed as described below); and,  
 $T$  is the number of weeks since initiation of shoring wall installation or excavation.

The time frame over which  $\alpha$  is computed changes depending on the phase of the work, as specified in the aforementioned letter. For the construction phase during which the shoring wall is installed (currently ongoing),  $\alpha$  is computed from the two months of monitoring conducted immediately prior to the shoring wall installation (i.e., monitoring data from February 22, 2022, through April 25, 2022). During the excavation phase (to occur in the future),  $\alpha$  will be readjusted to reflect the recorded lateral roof deflection rate in the two months immediately preceding the start of excavation (dates to be determined).

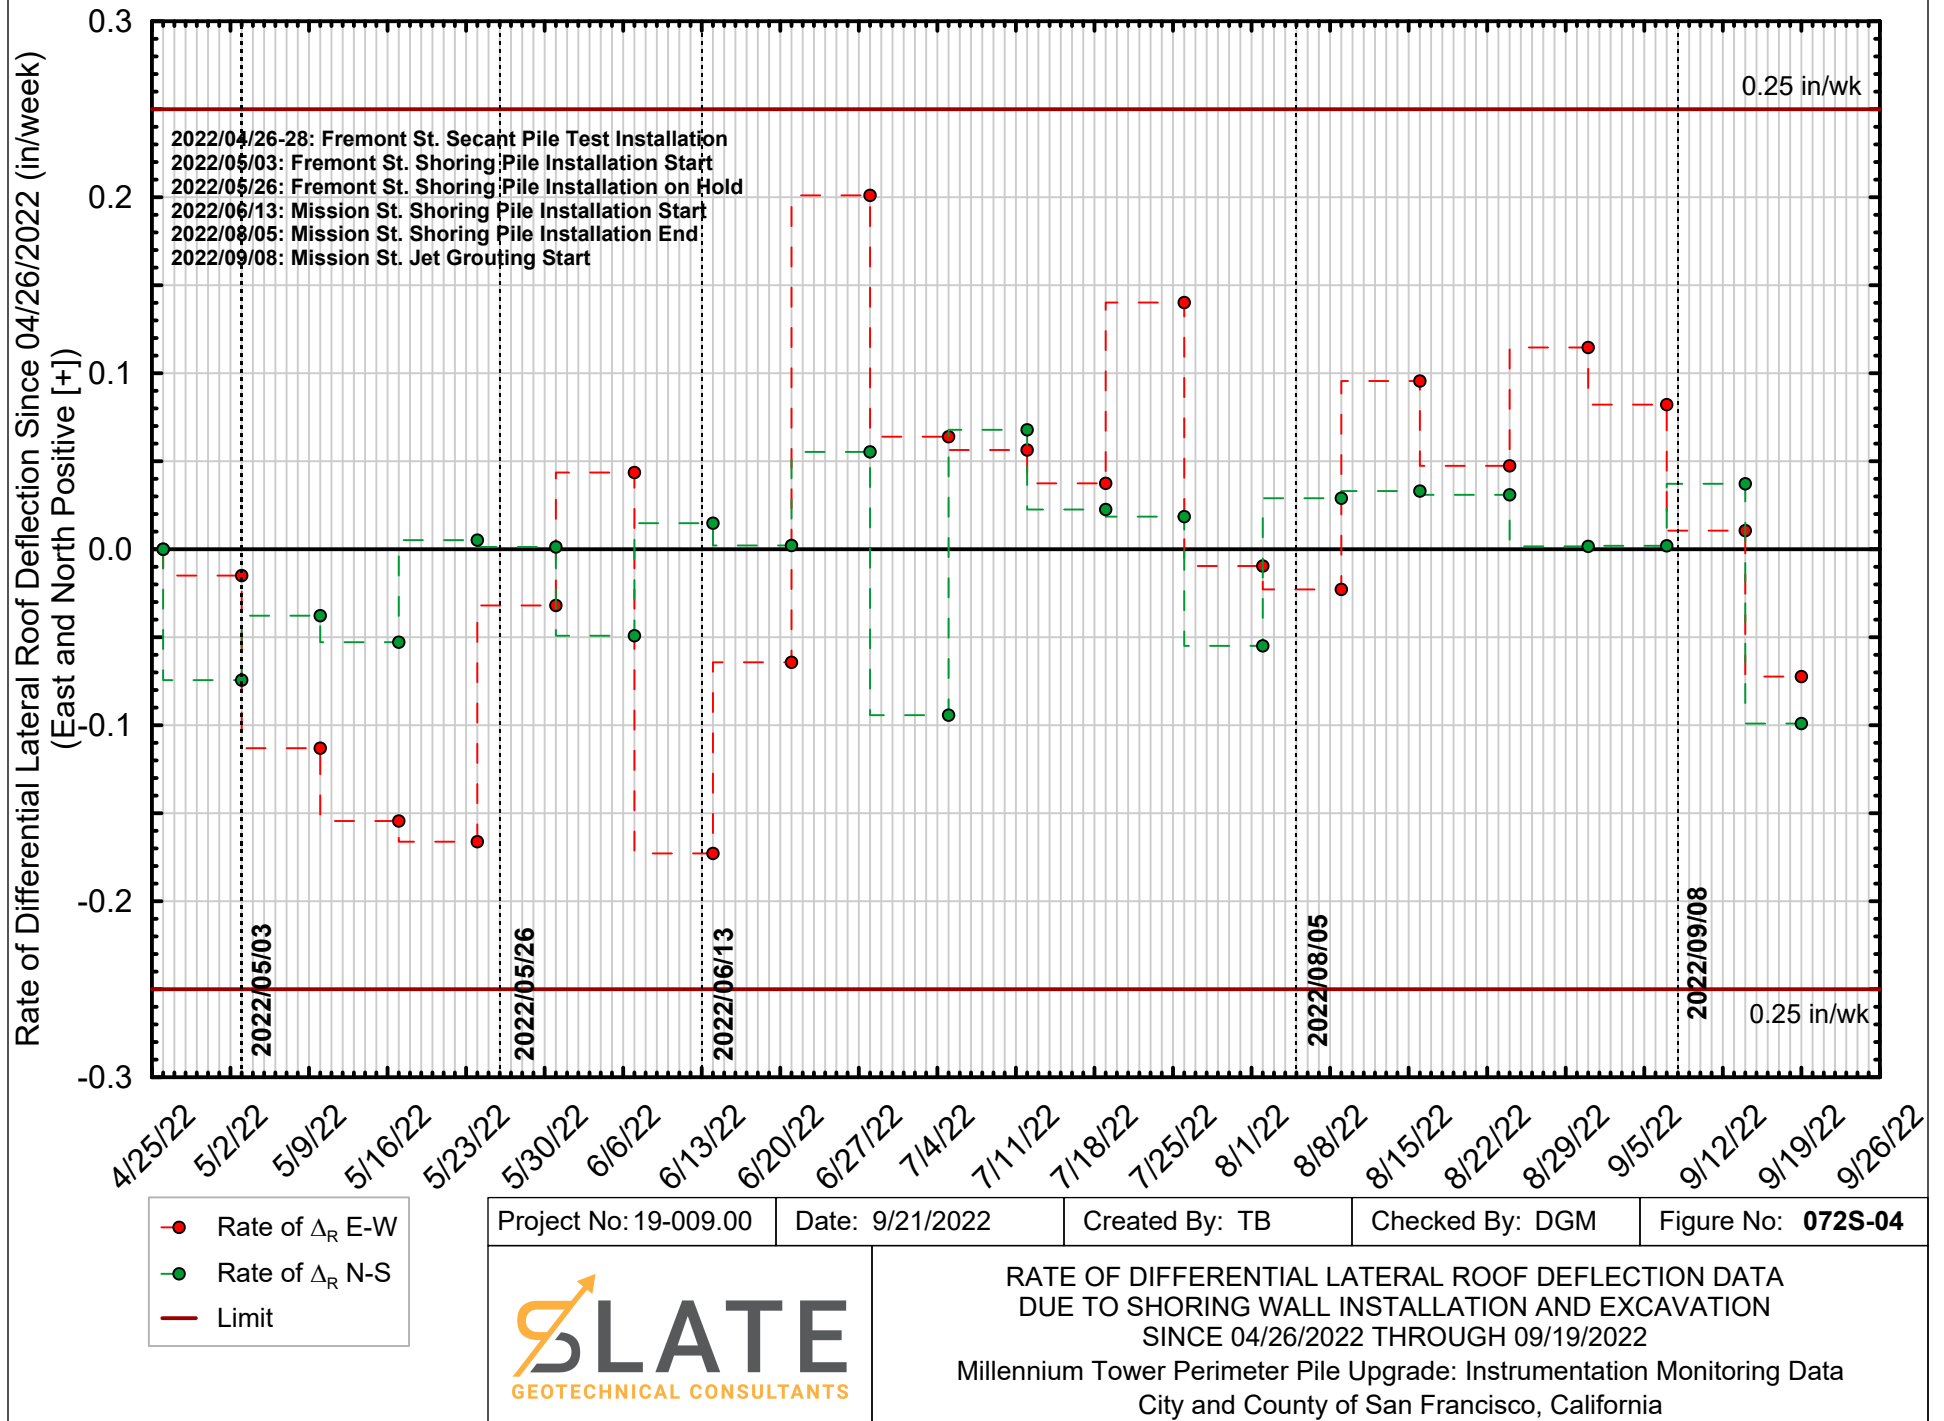
Figure S-04 – Rate of Differential Lateral Roof Deflection Data due to Shoring Wall Installation and Excavation since 04/26/2022 through 09/19/2022

Figure S-04 presents rates of differential lateral roof deflection data due to shoring wall installation and excavation since April 26, 2022, through September 19, 2022. Limits established in the aforementioned letter are included for reference. Note that the rates are calculated as:

$$\frac{d\Delta_R}{dT} \approx \frac{\Delta_{R,t} - \Delta_{R,t-1}}{T_t - T_{t-1}}$$

where:  $t$  is an index representing the current instance in time; and  
 $t - 1$  is an index representing the previous instance in time.
